Evaluation of Downstream Flood Hazard with HEC-RAS for Potential Overtopping and Piping Failure of Oyan River Dam, Abeokuta, Nigeria

ABSTRACT: This study presents a thorough dam break analysis of Oyan Dam, Nigeria, using the Hydrologic Engineering Center-River Analysis System (HEC-RAS) 6.6 software. The analysis simulated two hypothetical failure scenarios: overtopping and piping, to evaluate hydraulic and flood risks associated with potential failure of the dam. Breach characteristics were calculated using Froehlich's analytical formulas, and unsteady flow simulations were conducted for an 11 km downstream reach. Key hydraulic parameters, including peak discharge, stage elevation, flow velocity and flood wave travel time, were computed. Results revealed that the overtopping scenario produced a higher peak discharge of 22,556.47 m³/s at the dam and greater flood velocities of about 10.24 m/s, whereas the piping failure produced a lower peak discharge of 17,140.02m³/s. In both scenarios, flood wave propagation was characterized by deeper inundation near the dam and progressively reduced flood depths downstream. Floodplain mapping using HEC-RAS Mapper revealed extensive inundation o

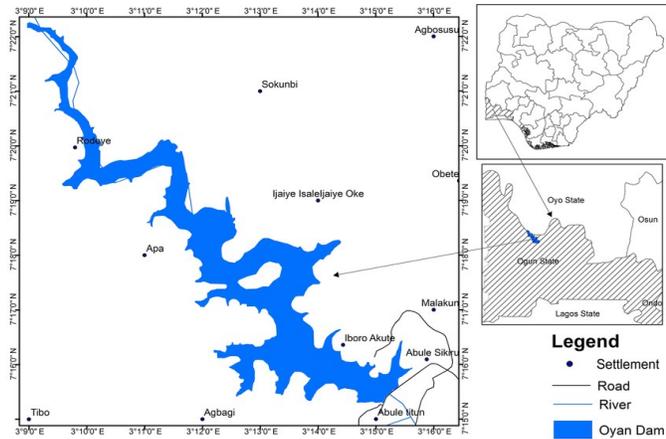
Figure 1 Oyan river dam catchment area

Oyan river dam is situated along latitude $7^{\circ}15'$ to $7^{\circ}25'N$, and longitude $3^{\circ}08'$ to $3^{\circ}16'E$ at an elevation of 43.3 m above sea level. Located at the confluence of the Oyan and Ofiki rivers (tributaries of the Ogun River), the dam is approximately 20 kilometres northwest of Abeokuta. The dam's catchment area (Figure 1) covers around 9,000 km², with a reservoir spanning 4,000 hectares. Owned and operated by the Ogun-Osun River Basin Development Authority (O-ORBDA), the dam was commissioned on March 29, 1983. The Oyan river dam is characterized by a hummocky terrain with an undulating topography featuring forested hills and swampy lowlands with low fertility. At the downstream of the dam are settlement communities including, AbuleSikiru, AbuleTitum and Ibaro (Ayeni and Ojifo, 2018; Eruola, 2017). The structure comprises a 32.5 m high earth-fill embankment with a gated concrete service spillway and auxiliary spillway. Figure 2 showing the gated concrete spillway consists of a central portion with 4 radial spillway gates and three outlet valves, which maintain a normal water level at an elevation of 63 m. Its main functions are water supply and irrigation for the city of Abeokuta and parts of Lagos with the potential for hydropower generation (Ayeni and Ojifo, 2018).

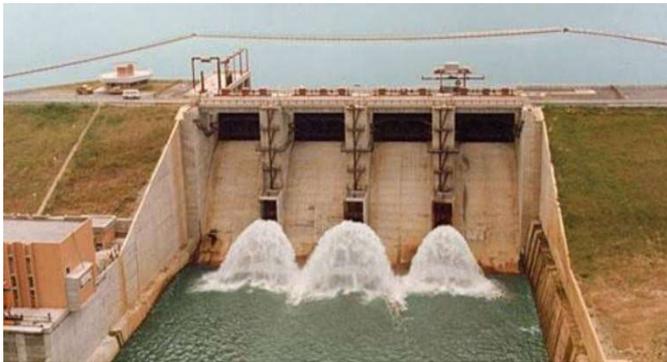
Figure 2 Oyan dam's concrete spillways and gates

The dam consists of a 32.5-meter-high earth-fill embankment, equipped with a gated concrete service spillway and an auxiliary spillway. It has a gross reservoir storage capacity of 270 million cubic meters and a dead storage capacity of 16 million cubic meters. The dam is designed with a freeboard of 2.10 meters to accommodate a flood event with a 10,000-year return period. It features four spillway gates, each measuring 15 meters in width and 7 meters in height, along with three outlet valves, each 1.8 meters in diameter. Also, the length of the dam crest is 1044 m. The reservoir normal water level is 63 m with minimum and maximum water level at 47.5 and 65.5 m respectively. These components regulate and maintain a normal water level at an elevation of 63.0 meters. The Oyan dam was designed to supply 700 million liters per day (mld) of raw water for the municipal and industrial requirements of Lagos and Abeokuta (Ayeni and Ojifo, 2018).

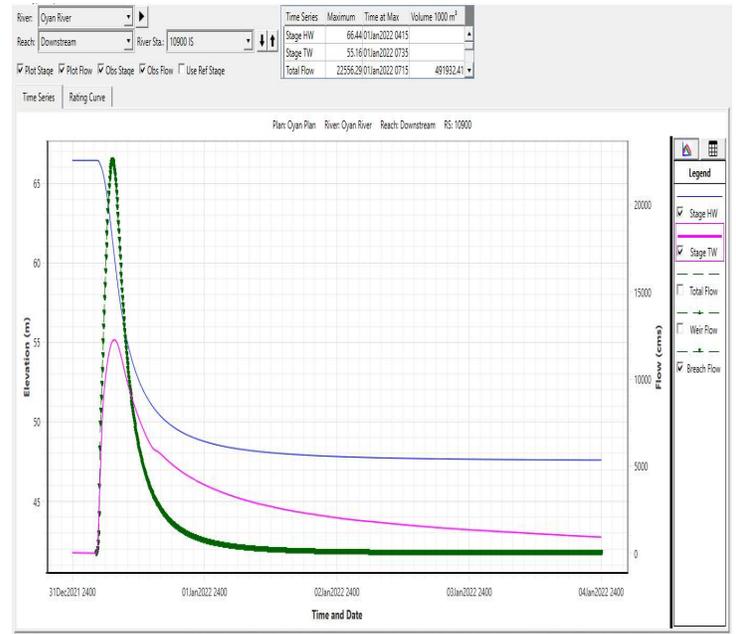
Figure 6 Stage and flow hydrograph for overtopping failure at inline structure

The simulation results in Figure 6 indicated a peak discharge of 22,556.47 m³/s and a flow velocity of 10.24 m/s at the dam structure. Figure 7 contains the corresponding rating curves of both the upstream and downstream sections generated for the overtopping failure at the inline structure, indicating its higher peak discharge relative to the piping failure. At the downstream end, approximately 11 km from the dam, the maximum discharge was 20,670.69 m³/s with a corresponding velocity of 3.88 m/s as shown in Figure 8. The reduction in peak discharge can be seen as it flows downstream of the channel. The flood wave attenuation gave a value difference of approximately 1885.78m³/s which accounts for the spread of water within the area considered. Comparisons with African dam-break studies also support these trends. The HEC-RAS modelling of the KesemKebena and Gidabo Dams in Ethiopia showed that peak breach outflows propagated downstream over long river reaches, with the highest flood stages and discharges occurring near the dams and progressively decreasing with distance downstream, a pattern consistent with the Oyan dam simulation (Kebede et al., 2020; Mekonnen et al., 2018).

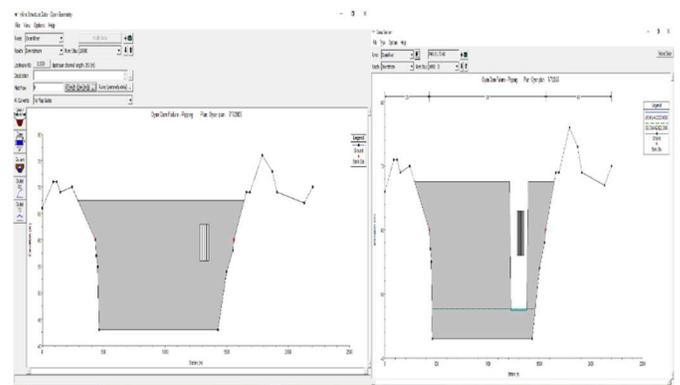
Figure 9 Before and after of simulation of piping failure

Figure 9 presents the dam cross-section before and after the simulation, respectively, illustrating the formation of the breach and reduced water level observed at the conclusion of the simulation. Figures 10 to 12 present the result of the stage and flow hydrographs together with the corresponding rating curve, at some selected cross-sections along the river reach. These locations include the dam site, immediate cross section downstream and terminal cross-section of the river reach as representative findings. From the start of the simulation, the peak discharge flow rate of 17,140.02 m³/s is observed at 7.92 hours at the inline structure. The result showed the stage

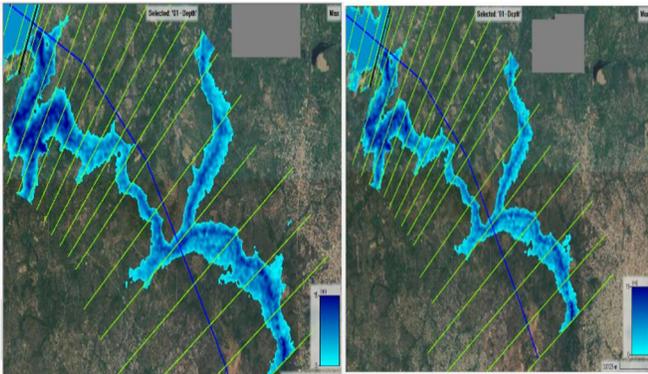
Figure 13 Inundation mapping for overtopping and piping failure respectively

HEC-RAS outputs were viewed in HEC-RAS Mapper and floodplain maps were generated. Figure 13 show the areas inundated as a result of overtopping and piping scenarios respectively. For the overtopping failure, the maximum flow depth ranges from 18 meters immediately downstream of the dam and reduced to approximately 3.15 meters at the downstream end of the river reach. The overtopping scenario produces greater flow depths, indicating a more severe threat to the downstream region. This finding is consistent with dam-break studies conducted in Nigeria and other parts of Africa, where overtopping failures were observed to generate higher flood depths and wider inundation extents than piping failures. For instance, a hypothetical dam-break analysis of Asa Dam, Ilorin, using HEC-RAS reported significantly higher downstream water depths under overtopping conditions compared with internal erosion scenarios (Balogun and Ganiyu, 2017). Similar outcomes were also reported for earth-fill dams in East Africa, where overtopping produced more destructive flood waves than piping failures (Kebede et al., 2020). In contrast, piping failure scenario results in lower flow depths ranging between 2 and 16 m, indicating a less dangerous scenario relative to the overtopping failure. This trend agrees with results from other HEC-RAS-based dam-break analyses, which observed that piping failures generally lead to lower flood depths and reduced downstream impacts due to slower breach development (Mohamed et al., 2023).

In the event of failure of the Oyan dam, the affected areas will be inundated with water having depths of about 15 m that reduces over time, with most affected areas covered in water for an average of three days. The Oyan river is a tributary to

the Ogun River with a channel which has dried up over the years, because of the erection of the dam along the Oyan river to supply water to Lagos and Ogun States. Immediately the dam fails, flood waters will be released to the channels supplying the Lafenwa river, a tributary to the Ogun River, thereby leading to the potential flooding of some regions in Lagos State, while also flooding surrounding areas along its channel. Other areas that could be potentially affected are Arakanga nature reserve, Awyan, Oloko, Iwofin, IwofinOtegbade and even the Abeokuta-Igboora-Iseyin road.
